Stanwood High School Stanwood-Camano School District

Commissioning Report October 2023

**Commissioning Report for
Stanwood-Camano School District
Stanwood High School**

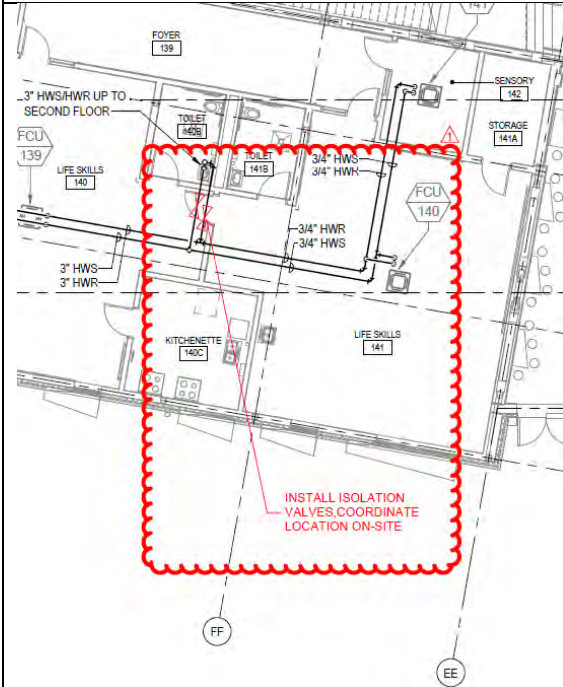
Isolation valves are already installed here but very high near the floor above. It may be more maintenance friendly to install on floor above.

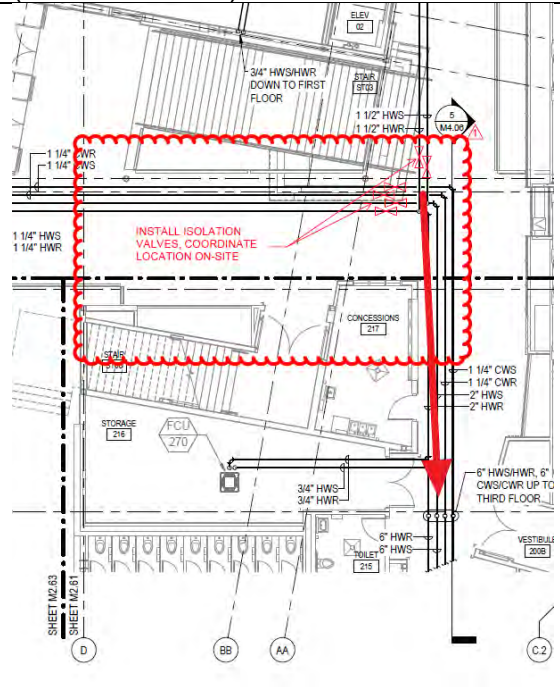
Recommend moving these proposed isolation valves to the south as shown below. Save money and better access (not above stairs).

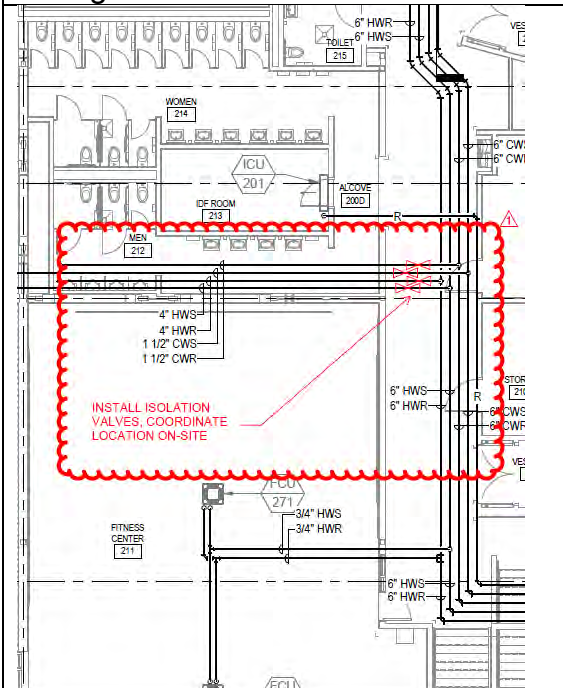
This location for isolation valves below may be too confining. May need to move to restroom ceiling or Admin ceiling.

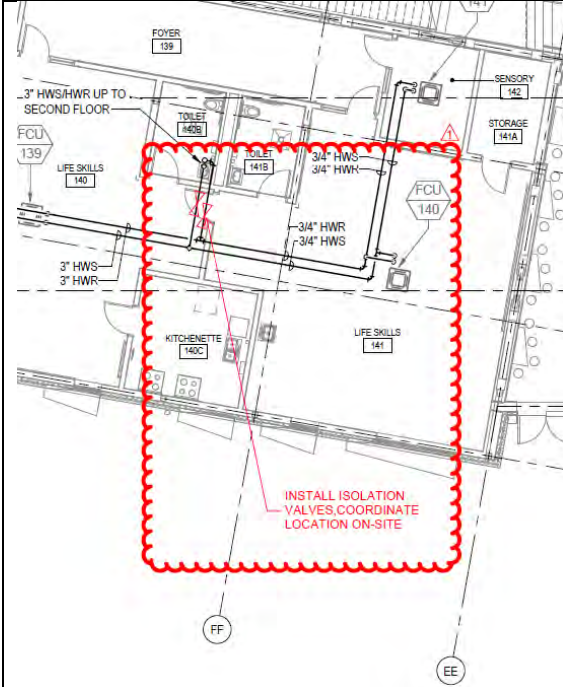
Isolation valves are already installed here but very high near the floor above. It may be more maintenance friendly to install on floor above.

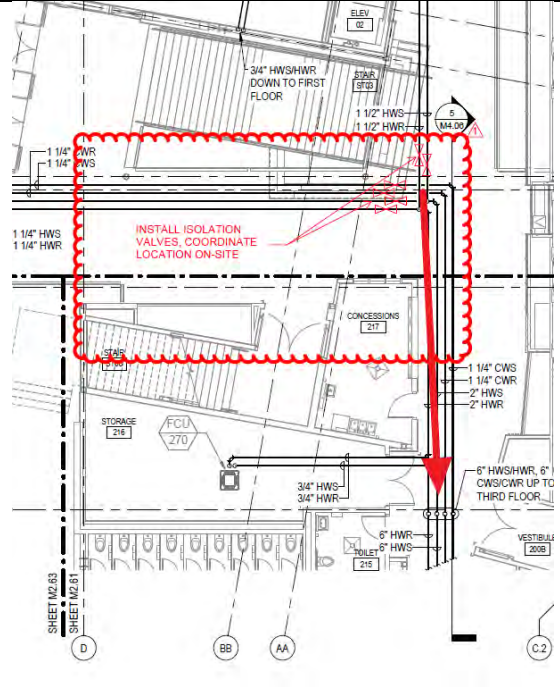
Recommend moving these proposed isolation valves to the south as shown below. Save money and better access (not above stairs).

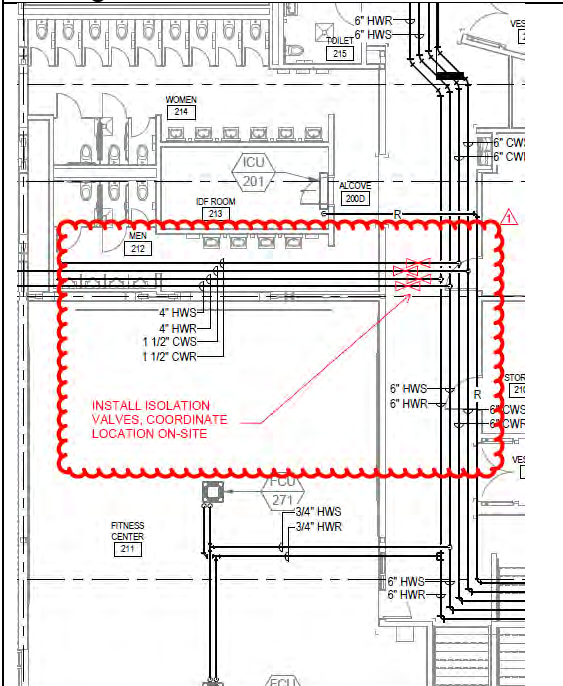
This location for isolation valves below may be too confining. May need to move to restroom ceiling or Admin ceiling.

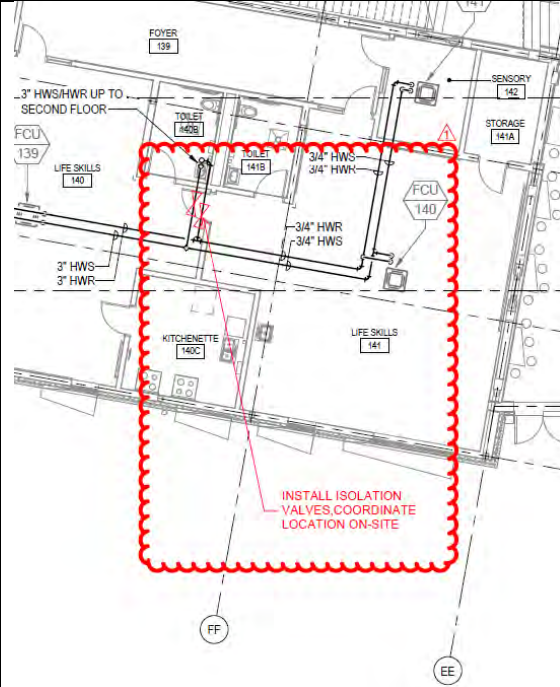
Isolation valves are already installed here but very high near the floor above. It may be more maintenance friendly to install on floor above.

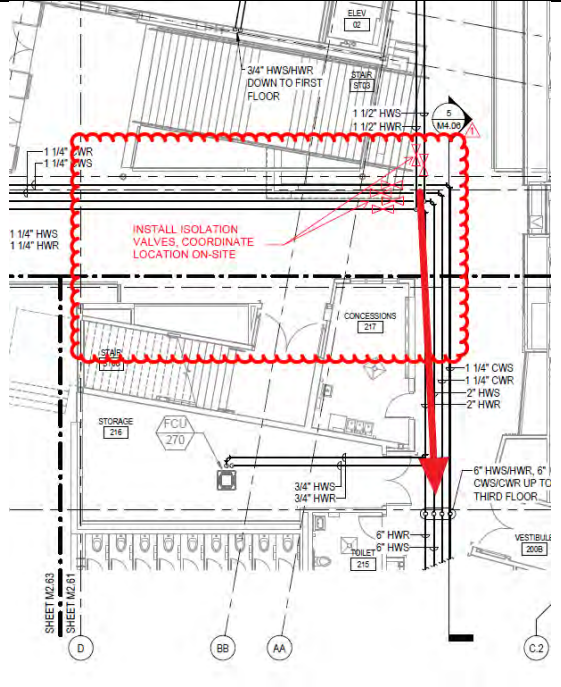
Recommend moving these proposed isolation valves to the south as shown below. Save money and better access (not above stairs).

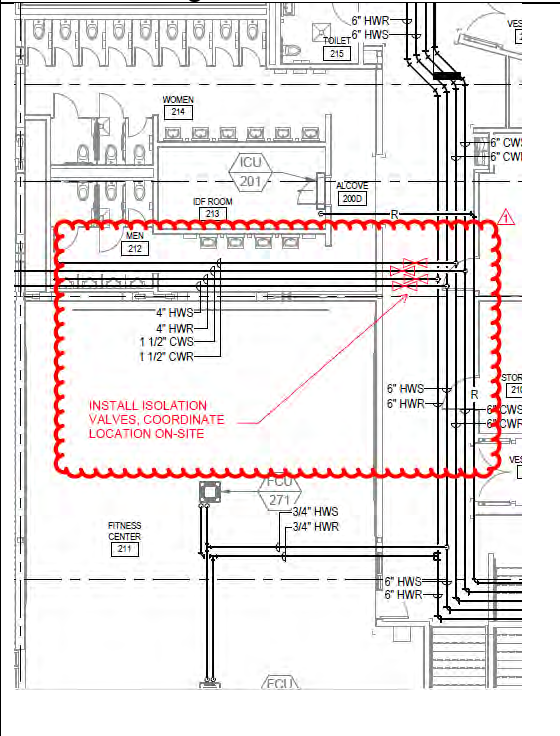
This location for isolation valves below may be too confining. May need to move to restroom ceiling or Admin ceiling.

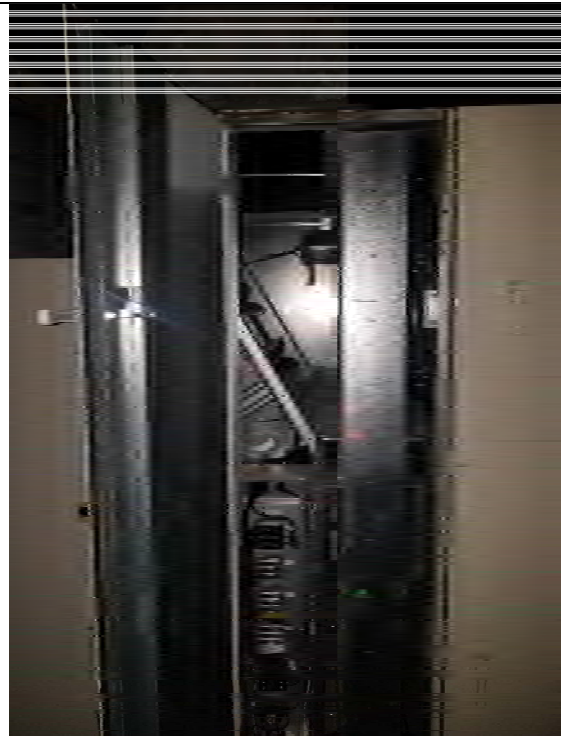
DOAU-01 Motor access and missing filter.

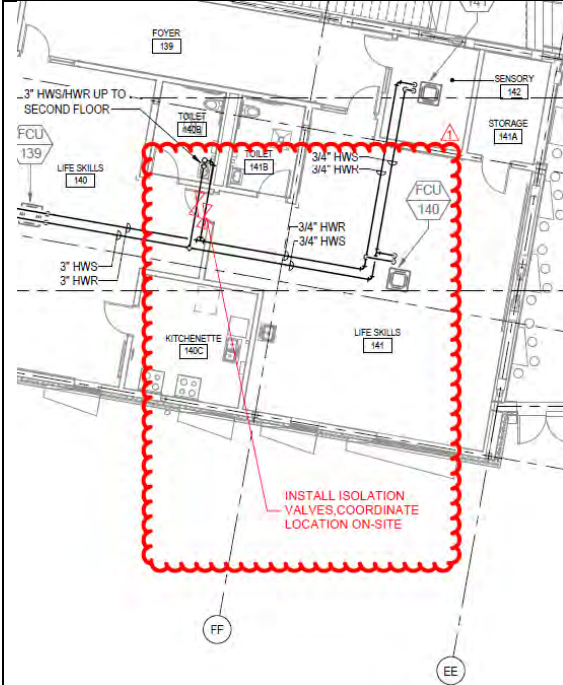
Isolation valves are already installed here but very high near the floor above. It may be more maintenance friendly to install on floor above.

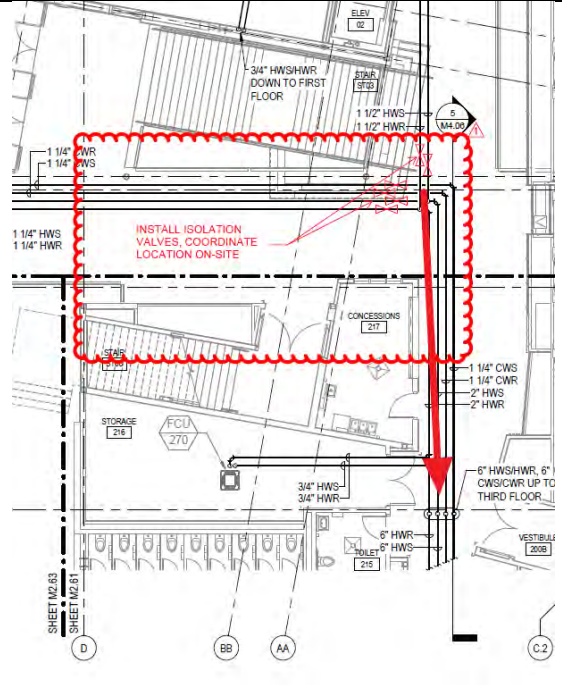
Recommend moving these proposed isolation valves to the south as shown below. Save money and better access (not above stairs).

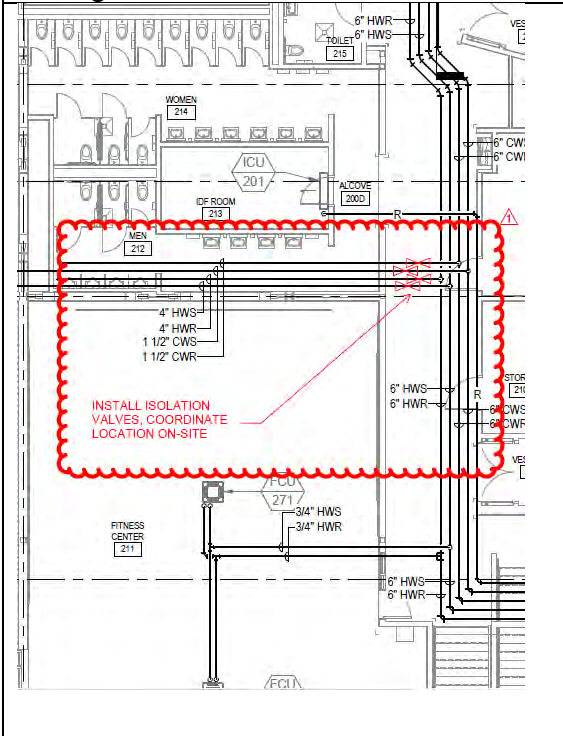
This location for isolation valves below may be too confining. May need to move to restroom ceiling or Admin ceiling.

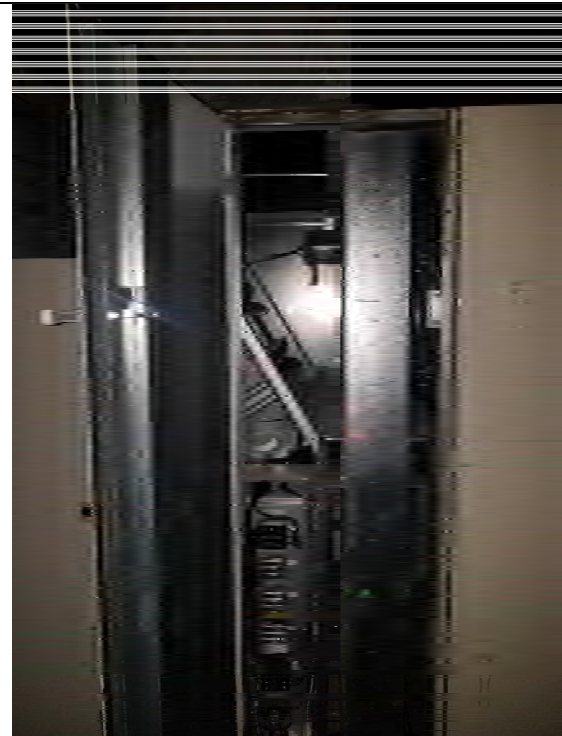
DOAU-01 Motor access and missing filter.

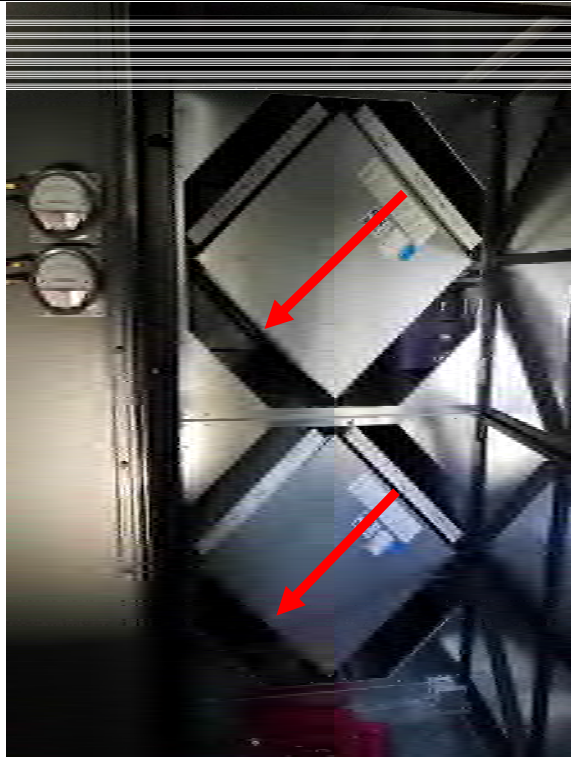
It appears that the exhaust filters are not located in correct location for DOAU-1 at the CTE building. The filters should be moved to location shown below.

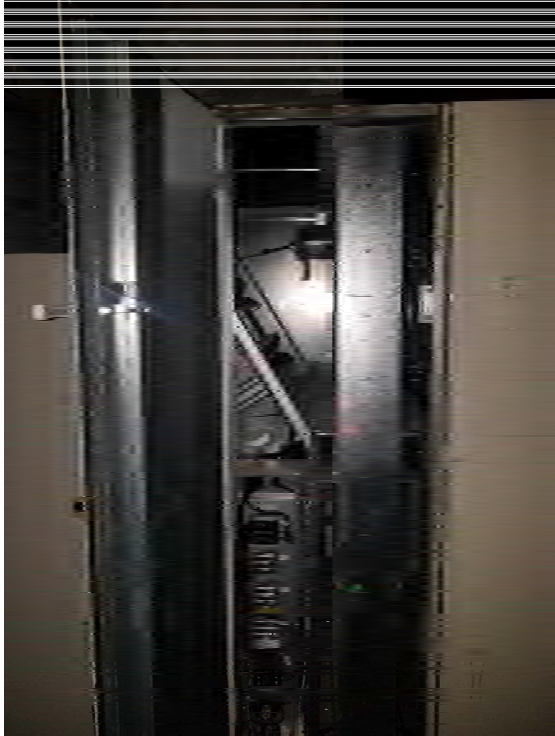
It appears that the exhaust filters are not located in correct location for DOAU-1 at the CTE building. The filters should be moved to location shown below.

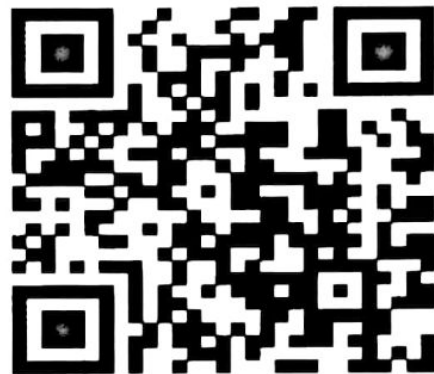
ORIFICE/
ORIFICES: 0.555 DMS / 14.1 DMS/mm

CATEGORY II OR IV
 CATÉGORIE II OU IV
 SHORT CIRCUIT CURRENT RATING: 5 Ka
 COURTE NOTE ACTUELLE DE CIRCUIT

ELECTRICAL RATING/PUISSANCE ELECTRIQUE NOMINALE: 208/230/1PH/60HZ MAXIMUM AMPS./AMP. MAXI: 13.1 A

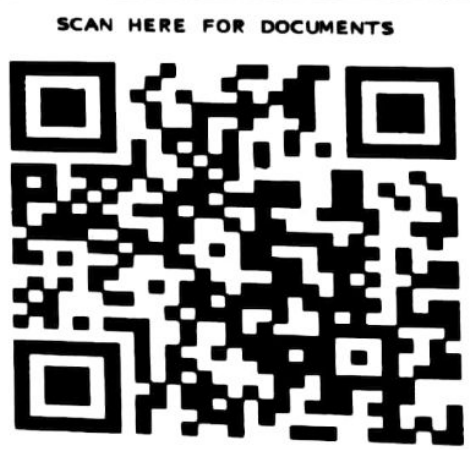
MAX. INPUT/ ALIMENTATION:	1,600,000 BTU / 489 kw	BTU/HR kw
MIN. INPUT/ ALIMENTATION MINI:	320,000 BTU / 94 kw	BTU/HR kw
MAX. OUTPUT/ PUISSANCE UTILE:	1,440,000 BTU / 422 kw	BTU/HR kw
MIN. OUTPUT/ PUISSANCE UTILE:	288,000 BTU / 84 kw	BTU/HR kw
ORIFICE/ ORIFICES:	0.555 DMS / 14.1	DMS/ mm

CATEGORY II OR IV
CATEGORIE II OU IV
SHORT CIRCUIT CURRENT RATING: 5 Ka
COURTE NOTE ACTUELLE DE CIRCUIT

ELECTRICAL RATING/PUISSANCE ELECTRIQUE NOMINALE: 208/230/1PH/60HZ MAXIMUM AMPS./AMP. MAXI: 13.1 A

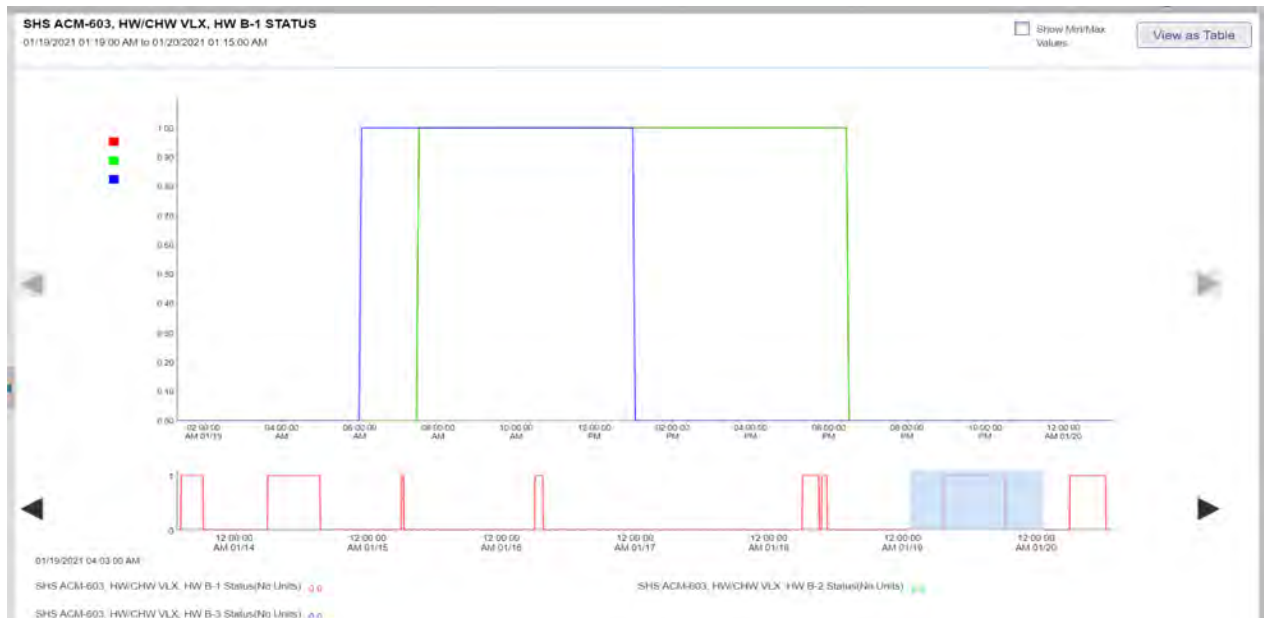
- **Screen shot of boiler status showing boiler 2 (Lead) and 3 (lag 1) “on” and master (Lag2) “off”.**

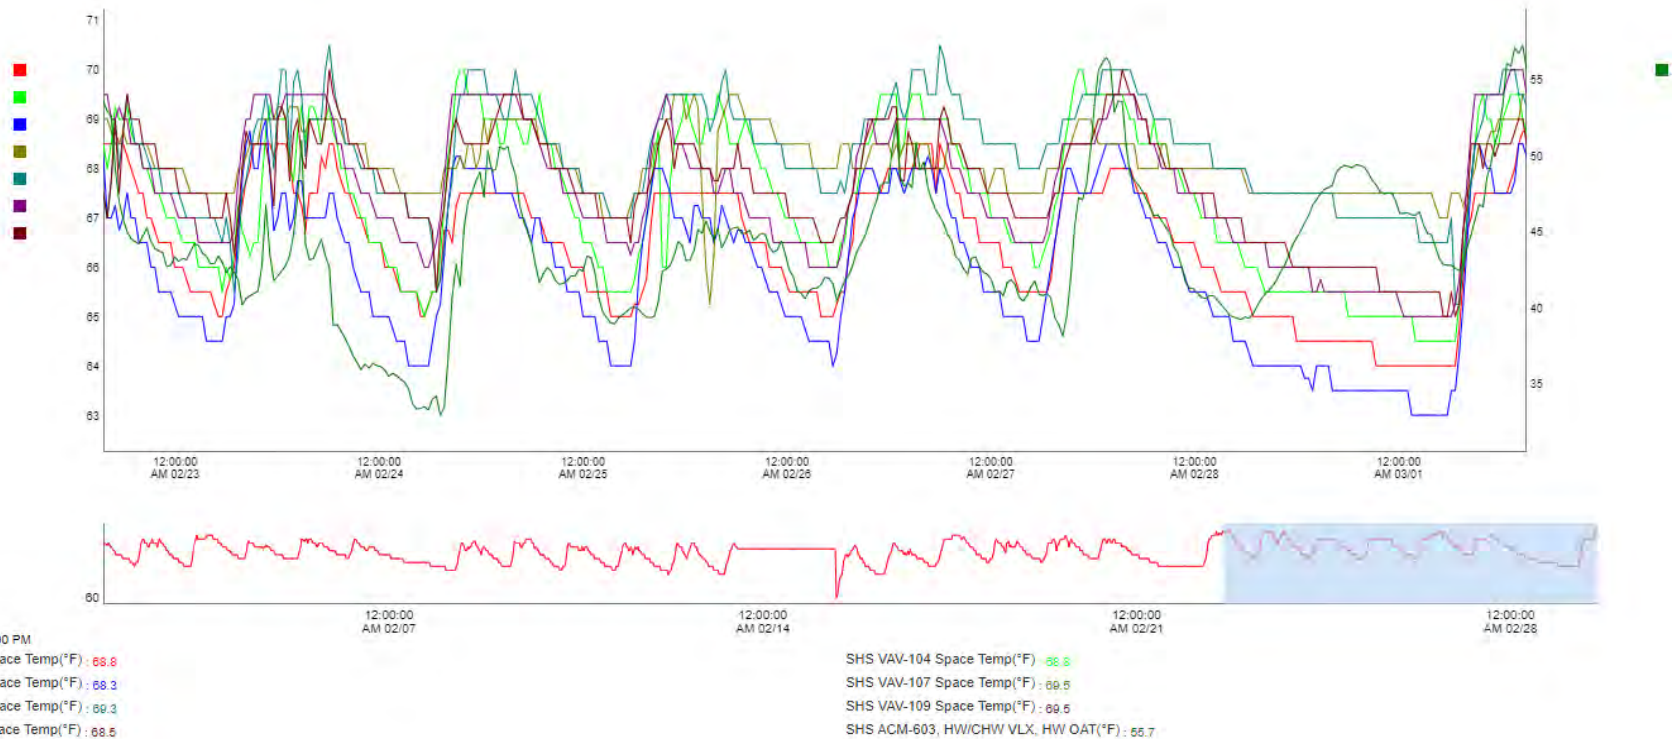
Comments: VAV's are linked to FCU's. Outside Air Temperature reference plotted on 2nd Y-axis. Verified FCU's run according to building schedule.

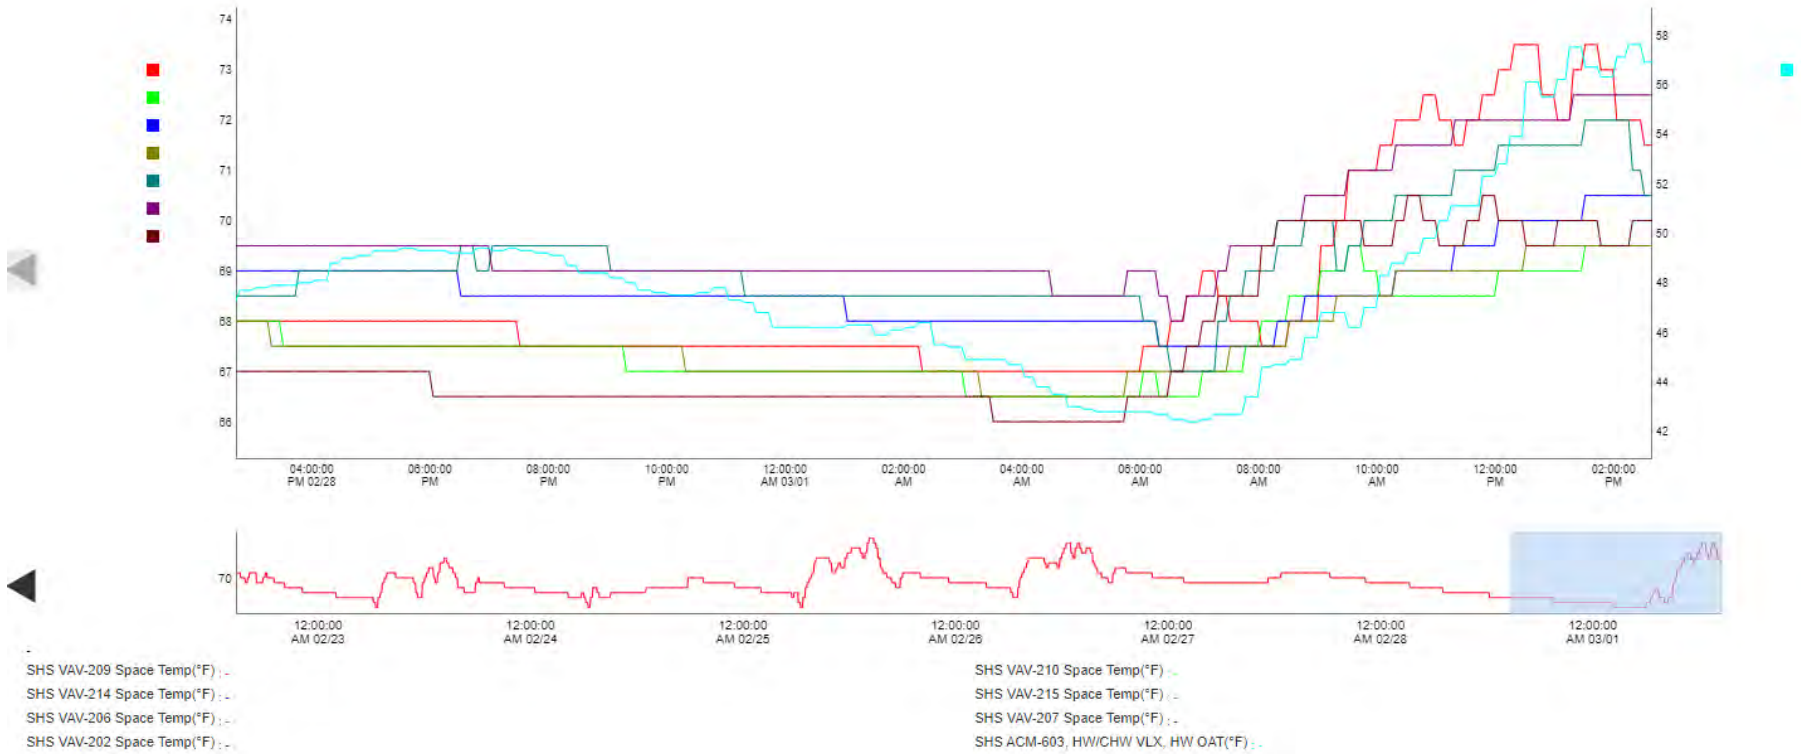
Comments: VAV's are linked to FCU's. Verified that the space temperature was rising before occupied time showing that the morning warm up works. Verified that the space temperature regulates to unoccupied heating set point during the weekend (Sunday 2/28/2021). Verified units regulate space temperature control to individual occupied heating setpoint. Outside Air Temperature reference plotted on 2nd Y-axis.

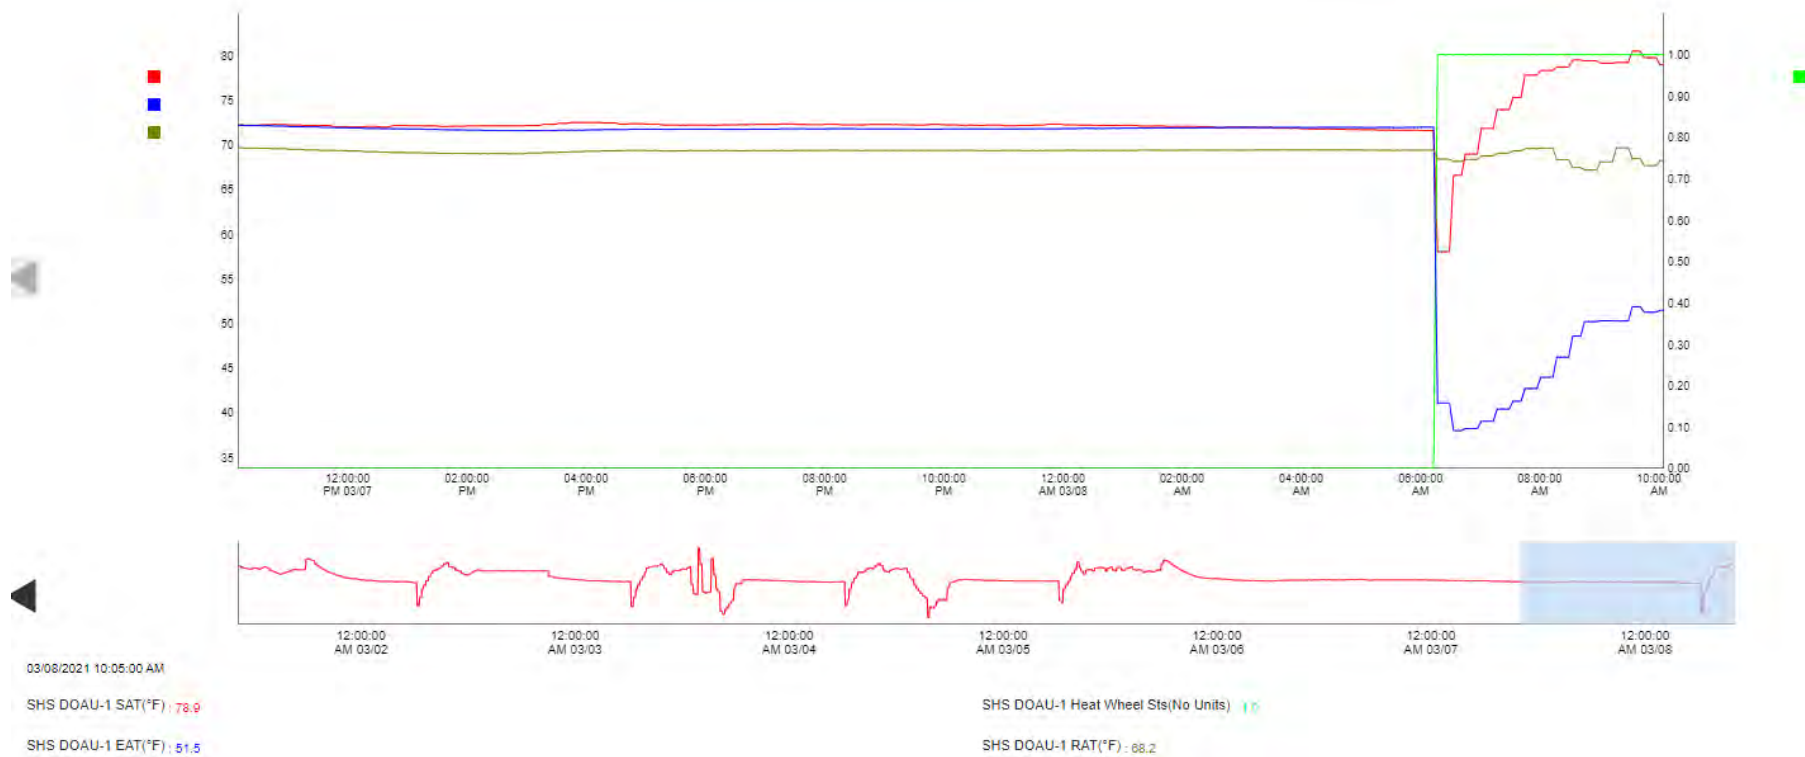
Comments: Verified the supply air temperature is controlled to setpoint while VAV boxes are calling for heating. Verified energy recovery wheel operates on building schedule. The energy recovery wheel will start when supply fan status is on and EAT and RAT differential is greater than 8°F.

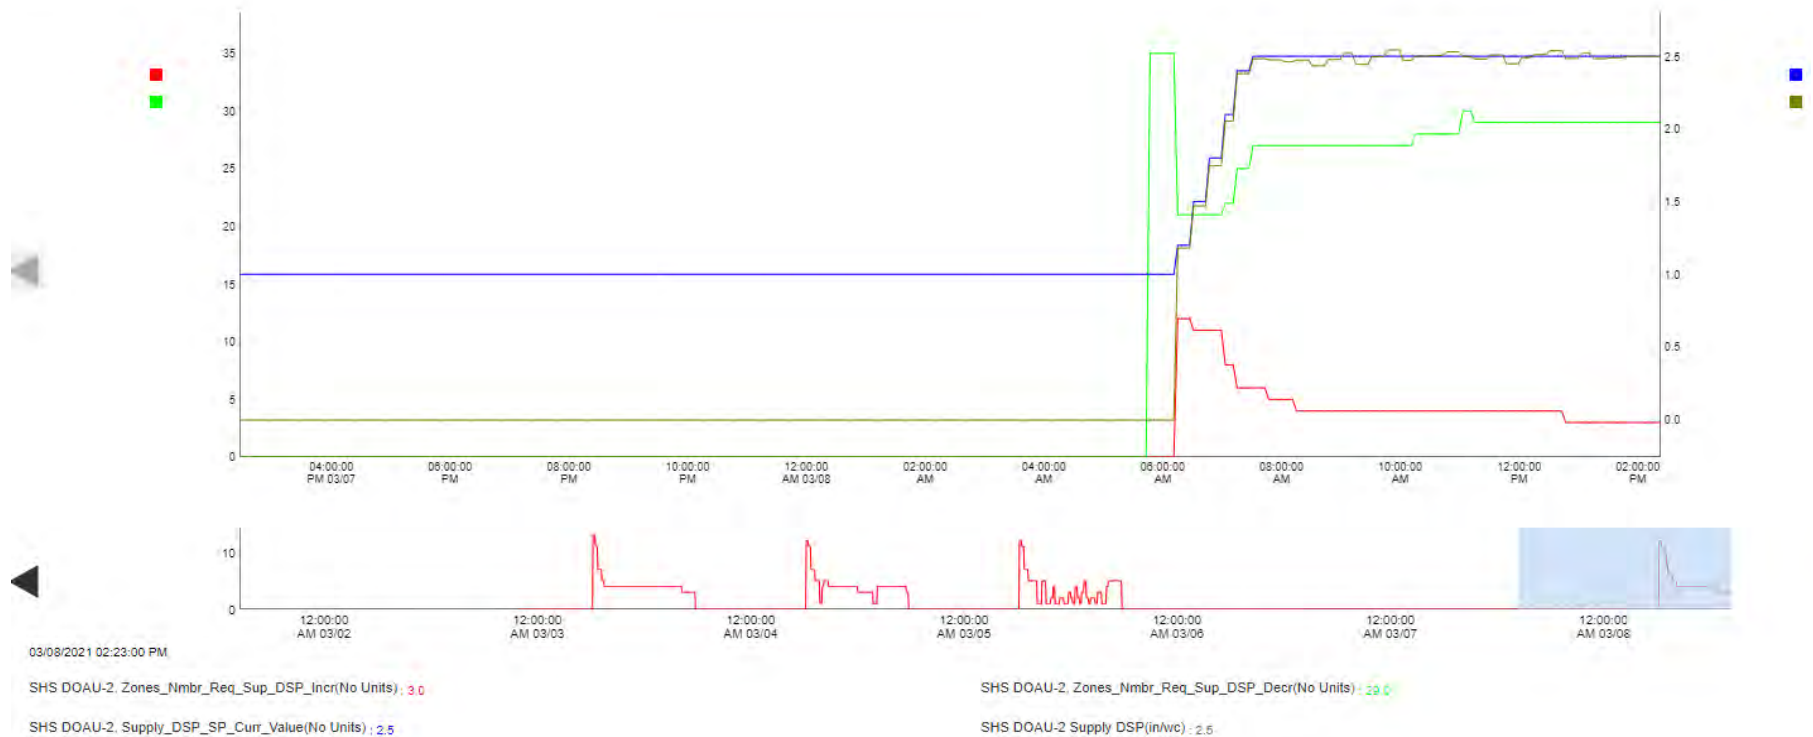
Comments: Verified unit regulates to Duct static Pressure Setpoint on supply side with multiple zones calling for an increase or decrease. Setpoints were trended starting on 3/3/2021.

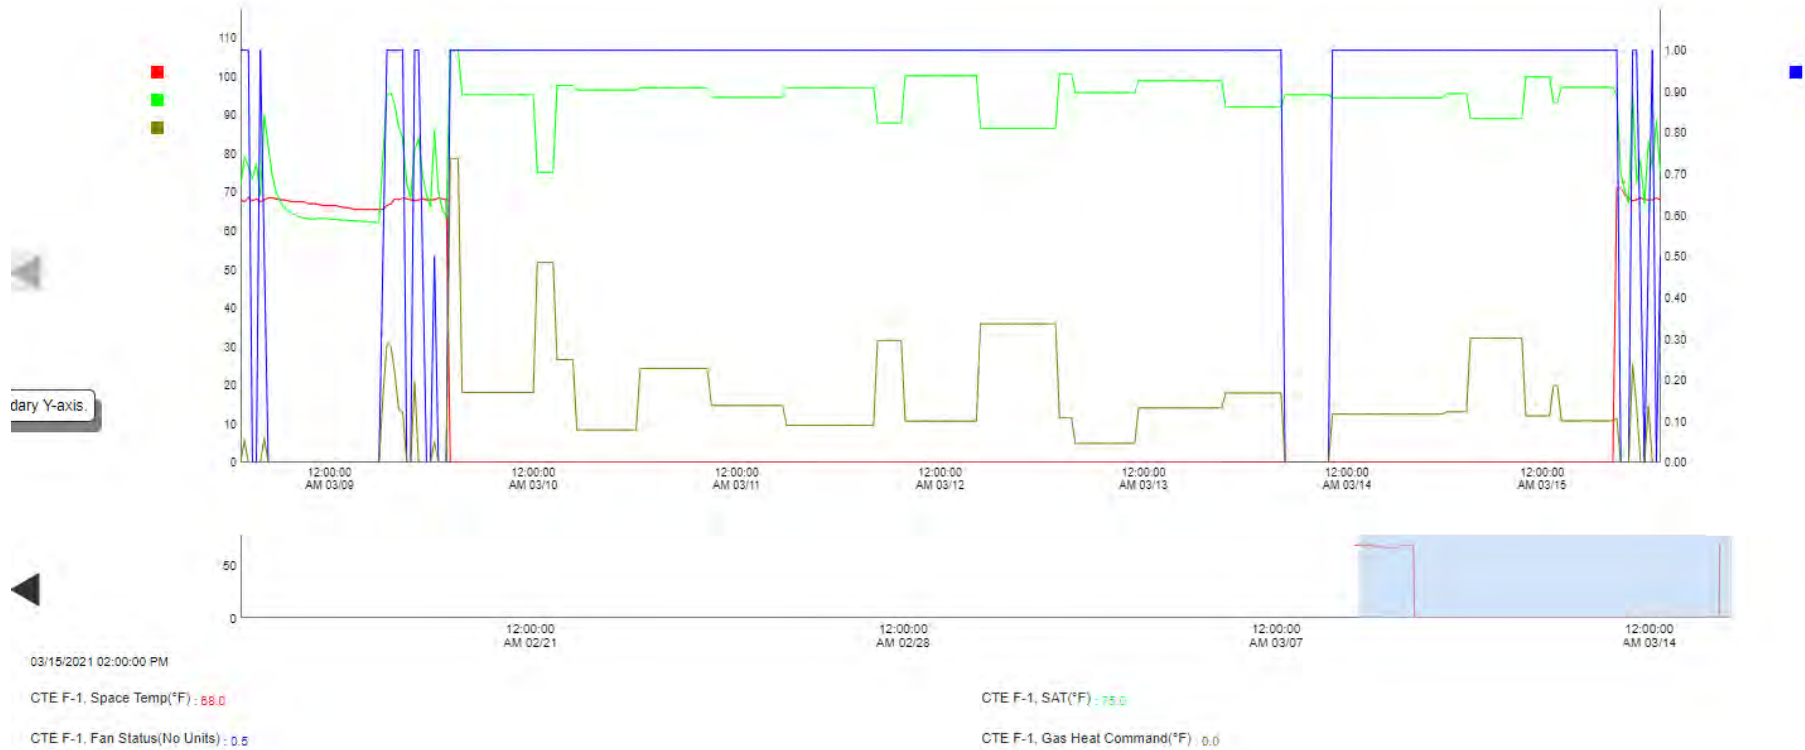
Comments: Verified space temperature controlled to occupied heating setpoint. Verified warm up mode works sufficiently. Shows issue with space temperature sensor that has been corrected.
